INDIAN LAKE DAM

**NDI ID NO. PA-01041
DER ID NO. 40-143**

PHASE I INSPECTION REPORT NATIONAL DAM INSPECTION PROGRAM

PHASE I. INSPECTION REPORT
NATIONAL DAM INSPECTION PROGRAM
BRIEF ASSESSMENT OF GENERAL CONDITION

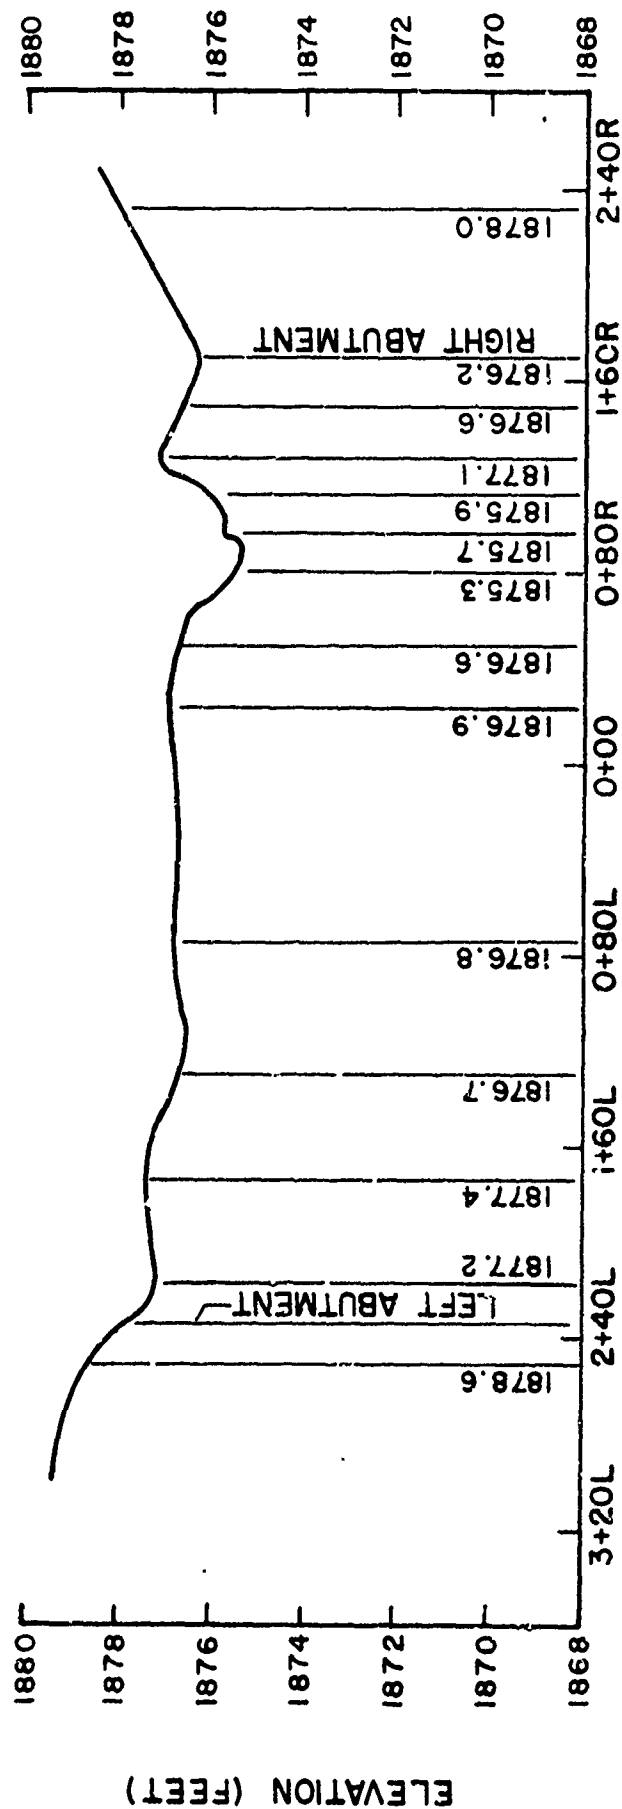
EXHIBIT A-1

TOP OF DAM - PROFILE
